LONG-TERM FIELD INVESTIGATION OF POLYMER COATED CORRUGATED STEEL PIPE

NATIONAL CORRUGATED
STEEL PIPE ASSOCIATION

March 2012

J. PETER AULT, P.E. – ELZLY TECHNOLOGY CORPORATION

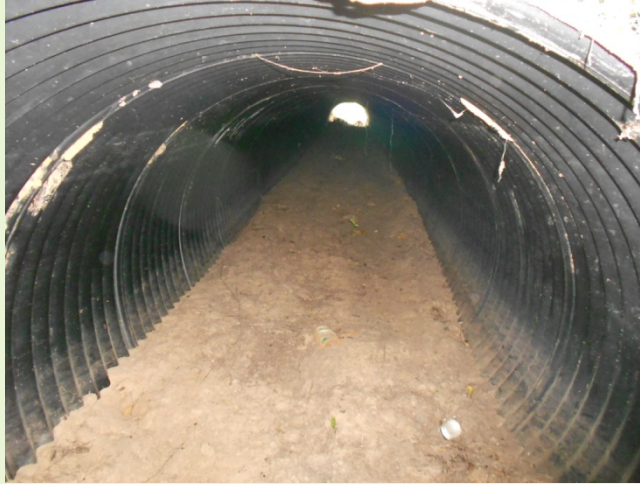
In June, 2011 seven corrugated steel pipes were evaluated along Grange Road in Sharp County, Arkansas. Each pipe was approximately 32 years old and all but one was found without any water running through them. The one that was found with water had a pH of 7.5 and a hardness of 125. The environmental properties of the water and soil resistivity for each pipe ranged from 3200 to 13500 and 2164 to 4475 ohm-cm, respectively. The pipe coating was in excellent condition with only a few minor flaws ranging from minor nicks and peeling at the exposed ends to some UV degradation at the exposed top.

After more than 30 years after their installation the pipes were in excellent condition and coating seemed to prolonged their service life. Figure 5 shows the typical conditions of the pipe.

Figure 5. Typical conditions of the pipes in Arkansas

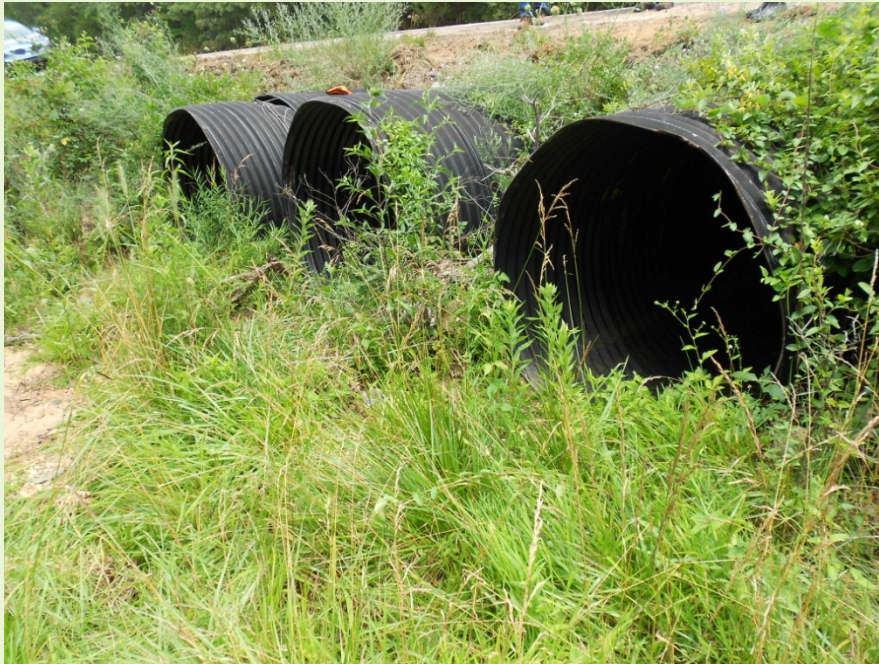
Figure 6. Exposed ends of the pipes in Arkansas

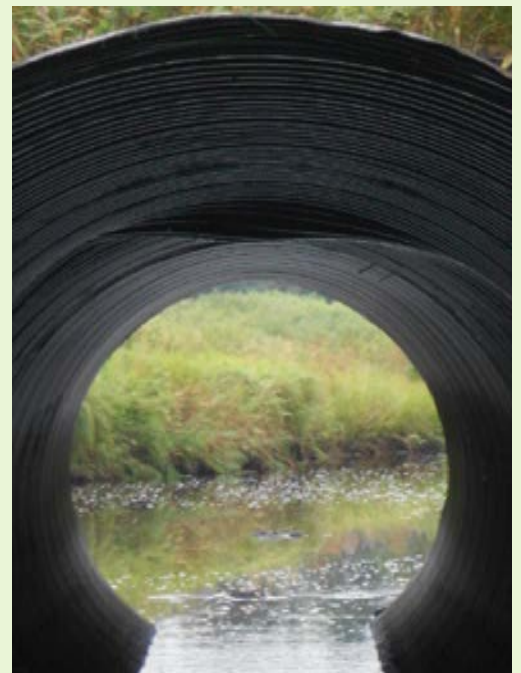
corrosion was noted at the cut ends. Structurally, most of the pipes were in excellent shape. Two of the pipes which were originally installed under a railroad line that is now used as a walking path exhibited some bowing or buckling likely due to construction loads but the coating was unaffected. Figure 7 shows minor buckling at the end of one pipe.

Figure 7. Long Lake installation WI-1. Note the polymer is in good condition. Buckling near the end appeared to have occurred during installation. No associated coating damage was noted.

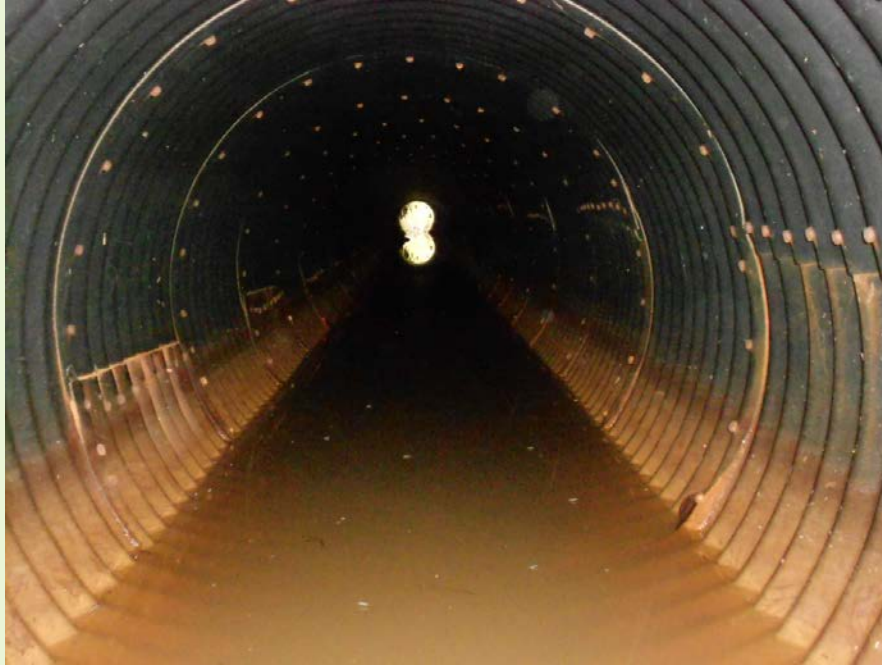
Figure 8. Babcock, WI. Typical good condition of Polymer.
The staining on the invert is superficial discoloration from the water line.

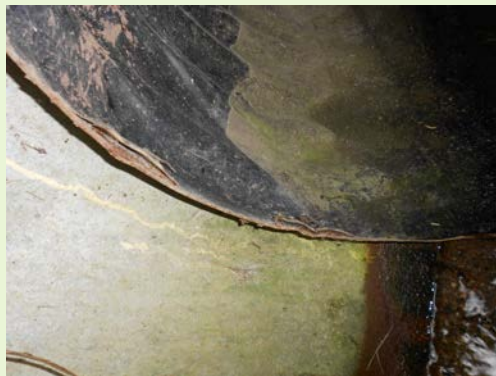
Figure 9. Minor delamination at the outlet of the pipe

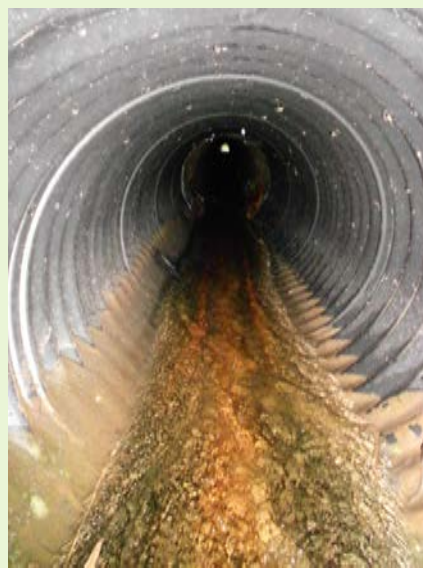
Figure 10. Typical conditions of coated pipe in New York

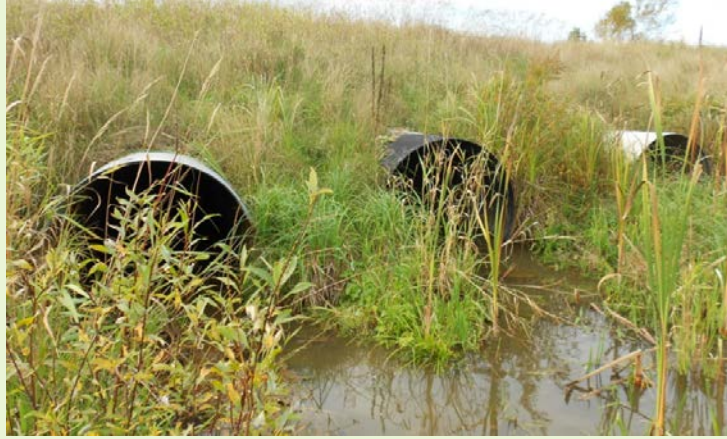
Figure 11. Pipes side-by-side under Hantz Rd.

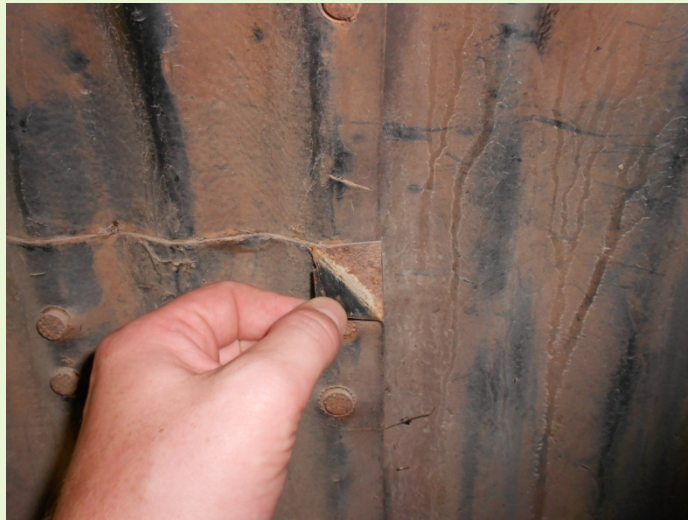
Figure 12. Minor delamination occasionally observed at cut edges. This is expected and has not seemed to be a life-limiting factor.

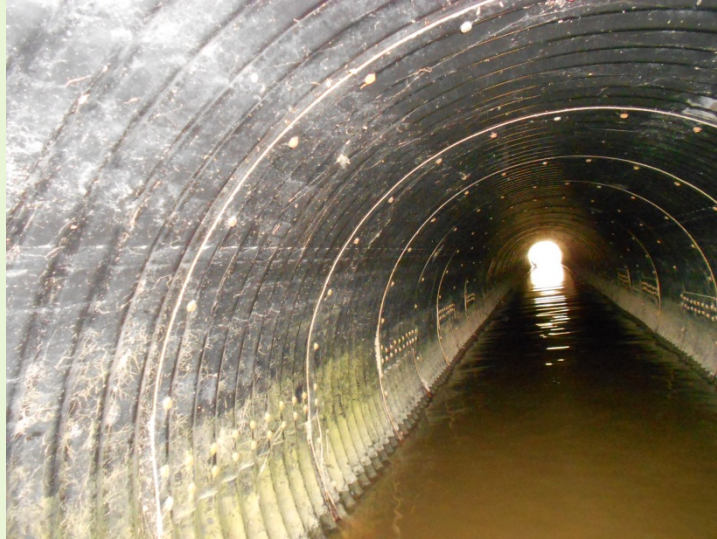
Figure 13. Typical good conditions of the polymer coating

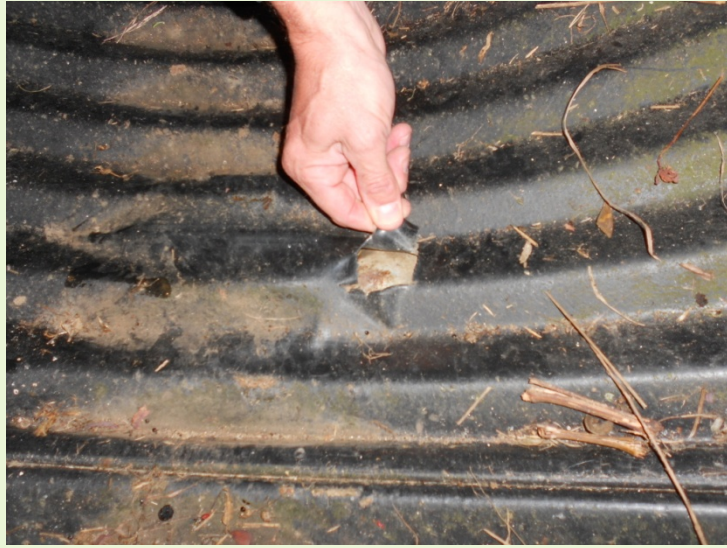
Figure 14. Minor delamination likely due to periodic heavy abrasion and fast flow

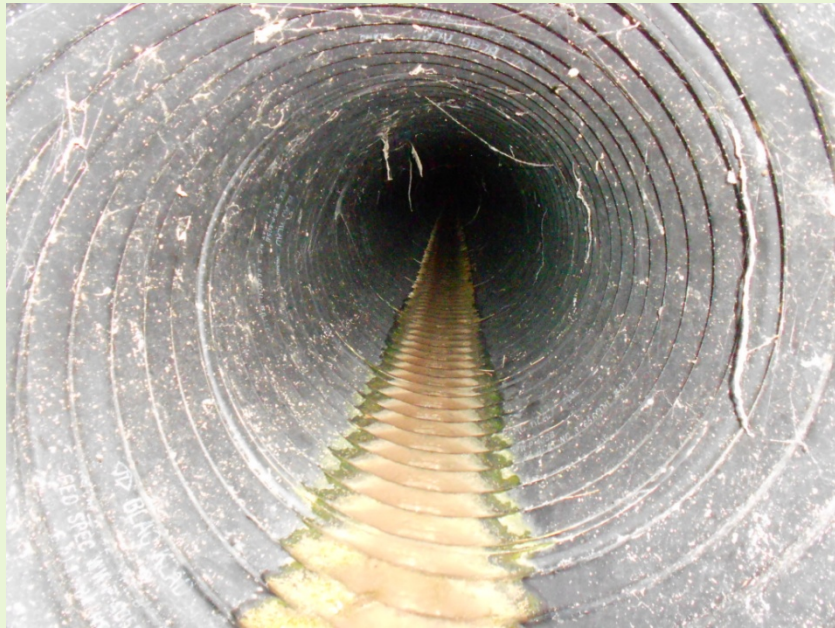
Figure 15. Typical good conditions of the polymer coating

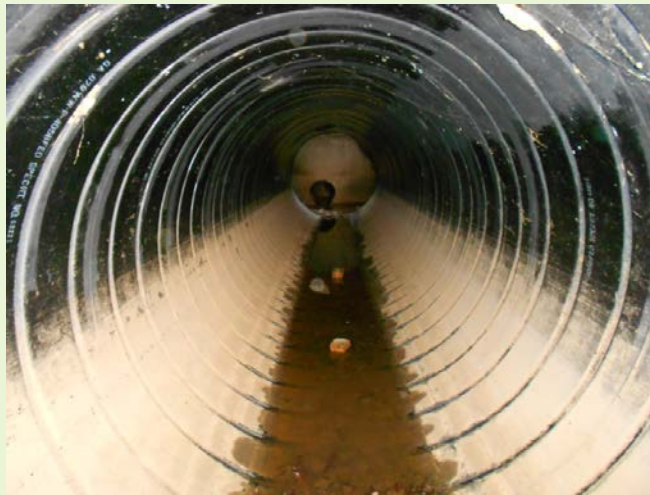
Figure 16. D'Arbonne Hills, conditions of the polymer found to be great condition

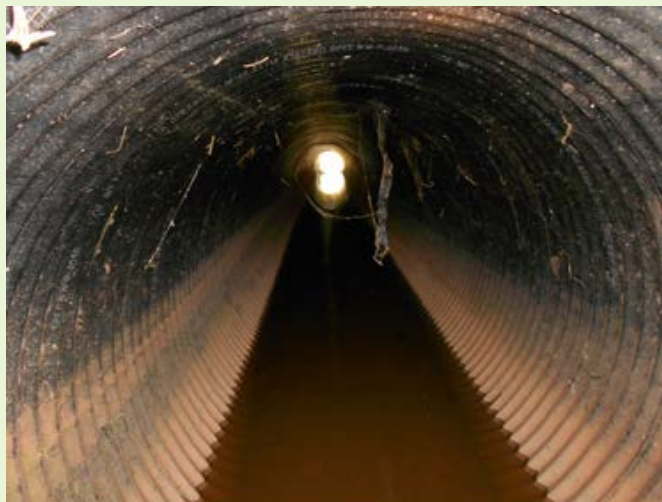
Figure 17. Example of polymer in good condition in Rapides Parish

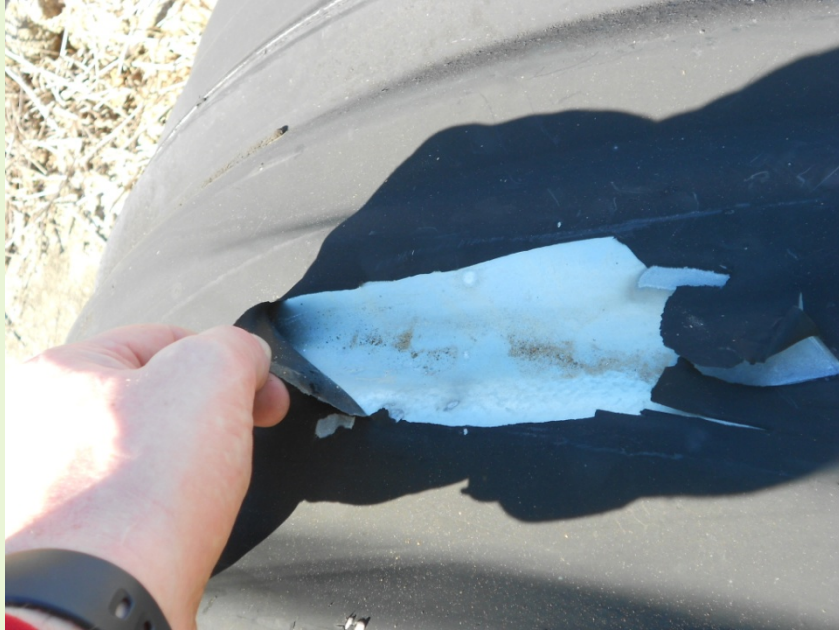
Figure 18. Delamination observed on the exterior of pipe on Joor Rd. likely due to 20 years of UV exposure
